Manhole Inspection Summary

Manhole # S25MM1001MH

Insp Date: **11/6/06 11:06 AM**

Location Address: **111 RIDGEWOOD AVE**

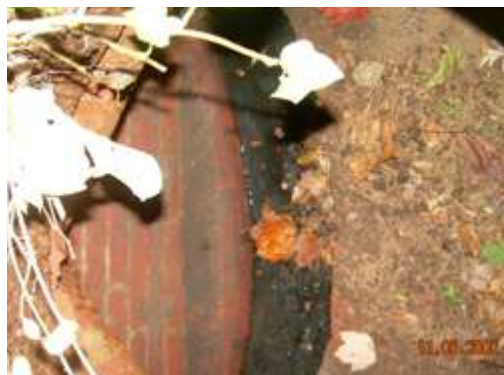
Top View

Bench ☒ Exists Material: **Brick** ☐ Parged ☒ **Debris** (not Condition related)

Channel Material: **Brick** ☐ Parged ☒ **Debris** (not Condition related)

Bench and Channel debris.

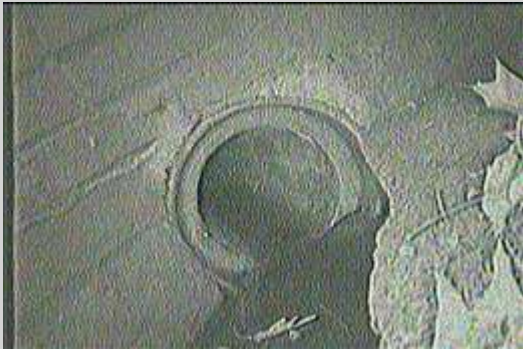
6 in. Circular Gravity Sewer Pipe Out @ 12 O'Clock

Pipe Material: **Clay** ☐ Pipe Lined

Invert Depth: **3.15** (ft.) Flow Characteristics: **Slow**

Deposits: ☒ None ☐ Mud ☐ Sludge ☐ Debris ☐ Grease

Infiltration: **None** Pipe Seal Cond: **Unknown**

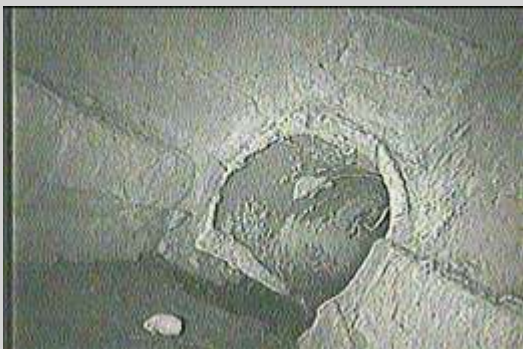
6 in. Circular Gravity Sewer Pipe In @ 8 O'Clock

Pipe Material: **Clay** ☐ Pipe Lined

Invert Depth: **3.10** (ft.) Flow Characteristics: **Slow**

Deposits: ☒ None ☐ Mud ☐ Sludge ☐ Debris ☐ Grease

Infiltration: **None** Pipe Seal Cond: **Unknown**
